TACARE NEWSLETTER

TAIwan Confidential Aviation safety REporting system

TACARE-09

June 2004

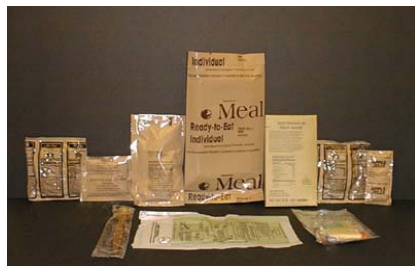
According to the information gathered by the TACARE task force, Military, Meals, Ready to Eat (MRE) are specifically designed for military purposes. When regular army provisions are not available, MRE foods can be used as substitutes. As Fig.1 and 2 show, such MRE foods' packaging are similar to the prepackaged instant foods that can be bought in a market.

reveal that these heating packs do possess the ability to ignite fire. Although this case occurred within the United States, an increasing number of compatriots are bringing their own food aboard and the instant foods with self-heating devices are becoming more and more common in markets. For this reason, through this report, TACARE task force hopes to not only remind aviation personnel to be cautious, but also to suggest passengers not to bring such heating devices aboard flights.
