EDITORIAL

NATIONAL AVIATION SAFETY INFORMATION

Recently Completed Investigations

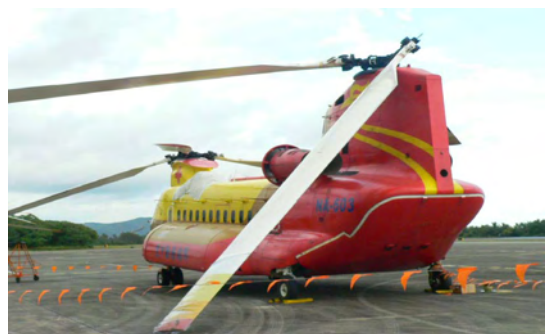
Figure 1 The rear blades' fractured blade damper/shock absorber resulted in the blade's collapse and striking the fuselage

The investigation revealed fatigue crack found on the blade damper/shock absorber as a result of air corrosion. Since the operator of the rotorcraft did not comply with the published airworthiness directives to conduct scheduled maintenance checks. The fatigue crack was not discovered, and as the crack progressed, the blade damper/shock absorber was weakened and eventually failed to absorb the stress resulted in the fracture of the component.

The ASC recommended the rotorcraft's operator to review and strengthen its management and maintenance practices with compliance to the proper Airworthiness Directives to avoid similar event.

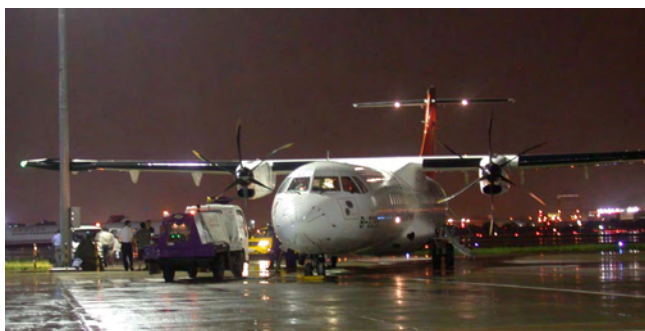
Figure 2 The right wing of the aircraft struck flood light pole during taxi

have realized the disappearance of the taxiway edge lights, the white marking lines on the road, and the unusual bright surroundings. However, the crew continued their discussion regarding taxing routings and failed to realize the right side of the aircraft was approaching the flood light pole. The aircraft continued taxing and eventually struck the light pole.

The ASC has issued the following recommendations to the aircraft operator: 1. Ensure that flight crew adhere to standard operating procedures and all regulations during taxing. 2. Enhance flight crew's training for situational awareness during taxing. 3. Ensure flight crew clearly stating their intentions to air traffic controller when requesting assistance.

The ASC also issued the following recommendations to the CAA: 1. Re-examine reflective material used for runway and taxiway markings to maintain consistent reflection rate. 2. Re-examine sign locations, sequence, symbols used, types, and substitution markings at Sung Shan Airport to ensure flight crew could clearly perceive their taxi routings. 3. Re-examine the conditions of the taxiway edge lights in Sung Shan Airport.

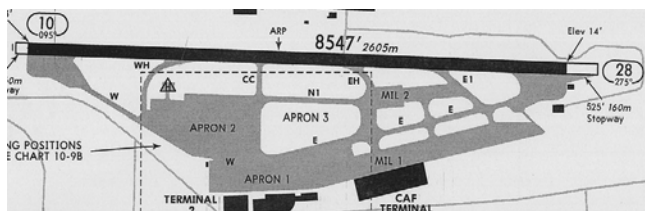
Figure 3 Jeppesen's aircraft diagram for Sung Shan Airport (RCSS)

using taxiway N1 after its construction work. While the aircraft made a right turn from Taxiway E into Taxiway CC, the flight crew saw sign 1 on figure 4. The sign led the flight crew to believe after the aircraft turned into Taxiway CC, the first Taxiway intersection of the right would be N1. However, there was a ground service road paralleled to Taxiway N1 behind the direction sign. The service road was not shown on Jeppesen's airport diagram (figure 3)

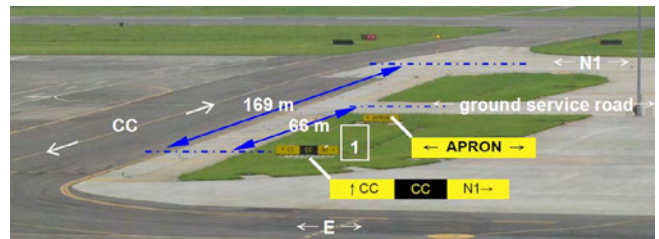
Figure 4 Locations of the information signs along side of Taxiway

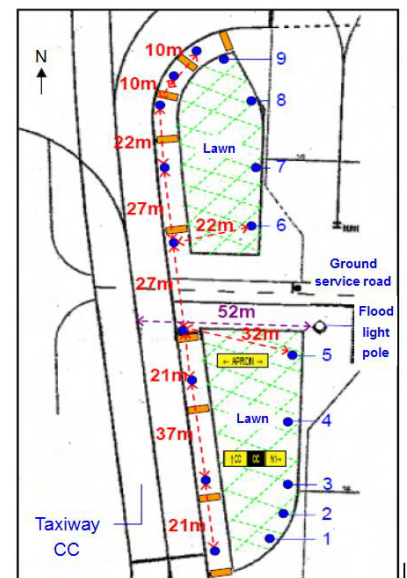
According to the flight crew, due to the weather condition, and light reflections from standing water accumulated on the ramp, both crew were unable to observe Taxiway centerline and edge line when the aircraft arrived the

Figure 5 Lights and lines nearby taxiway CC

intersection of Taxiway CC and ground service road. However, the crew did observe the taxiway edge lights, and they had mistaken the taxiway edge lights for gate number 3 (see item 5 and 6 on figure 5) as the edge light extensions into Taxiway N1. The flight crew advised the control tower that they were making a right turn. The control tower responded the phrase "roger" which led the flight crew to mistakenly believe that the control tower had identified their position and confirmed their taxi routings.
