EDITORIAL

NATIONAL AVIATION SAFETY INFORMATION

Bombardier BD700 N998AM veer off from the D taxiway of Kaohsiung International Airport

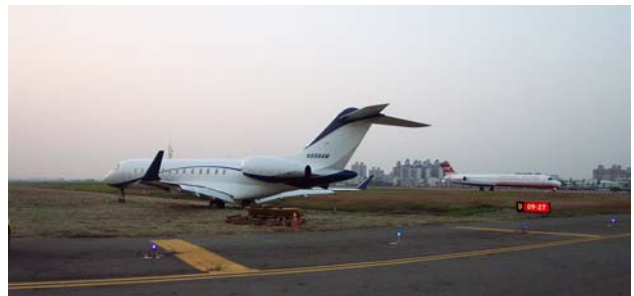
At 1447:17, with groundspeed of 14 kts, the aircraft began veering to the right. Approximately 10 seconds later, the aircraft made a right turn into Taxiway D and continue veering to the right. PM then indicated "Be careful! Stop! Stop!" while PF responded "Aircraft uncontrollable! Uncontrollable!" The aircraft veered out of Taxiway D with a groundspeed of 7 kts and came to a complete stop on the grass 30 meters right of Taxiway D. None of the crewmembers were injured.

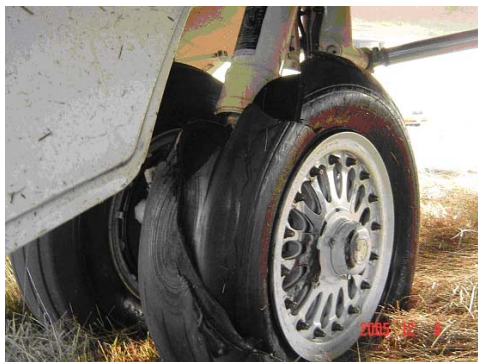
Since the aircraft is designed with a hydraulic reservoir for the brake system, the reservoir is capable of providing pressure to the brake system when normal hydraulic system failed. In this case, although the hydraulic systems have failed to provide normal braking, the backup system has provided an additional 1,500psi of hydraulic pressure. This enabled the PF to use differential braking pressure to turn the aircraft onto Taxiway D. However, the reservoir pressure was depleted after the turn resulted in the overrun of the aircraft.

The ASC has determined the probable cause was due to mechanical failure. An improperly installed internal seal on the number 2 main landing gear wheel's Brake Control Valve (BCV) caused the separation of the rubber particle from the seal. This resulted in the jamming of number 2 BCV. The hydraulic powered braking system operated normally upon touchdown. Under normal circumstances, when the number 2 main landing gear wheel's speed is lower than that of the aircraft (when the wheel begins rotating), the BCV

will release brake pressure to avoid wheel jamming. However, since the number 2 BCV has malfunctioned thus causing its failure to release adequate brake pressure. As a result, the wheel was jammed during landing roll.

The friction between the jammed wheel and the runway caused the tire to burst. The debris of the blown tire severed hydraulic lines causing the failure of hydraulic system 2 and 3. The nose gear steering system and brake system also failed as the result of the hydraulic systems failures.

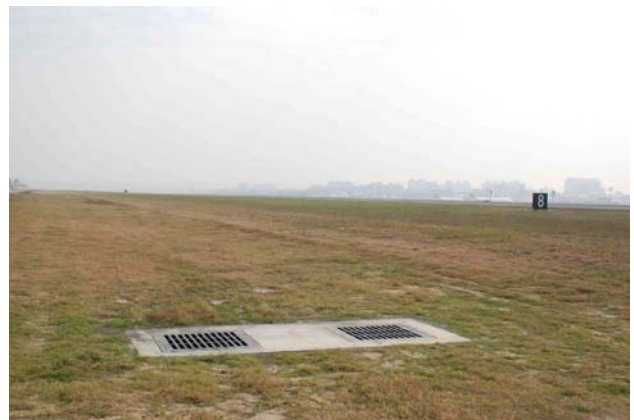
has revealed that Runway 09/27 were equipped with the uncovered V-shaped ditches or walls. Several taxiways were also equipped with the said V-shaped ditches. Such practice did not comply with the Civil Aerodrome Design and Operation Standard and could cause damage to the aircraft during a runway excursion. Thus, the ASC has issued a recommendation to the CAA. The CAA has already corrected the uncovered V-shaped ditches prior to the publication of the investigation report (see figure below).
